**NASA Contractor Report 172247**

**Re-Design and Fabrication  
of Titanium Multi-Wall  
Thermal Protection System  
(TPS) Test Panels**

**W. Blair, J.E. Meaney  
and H.A. Rosenthal**

**Rohr Industries, Inc.  
Chula Vista, California 92012-0878**

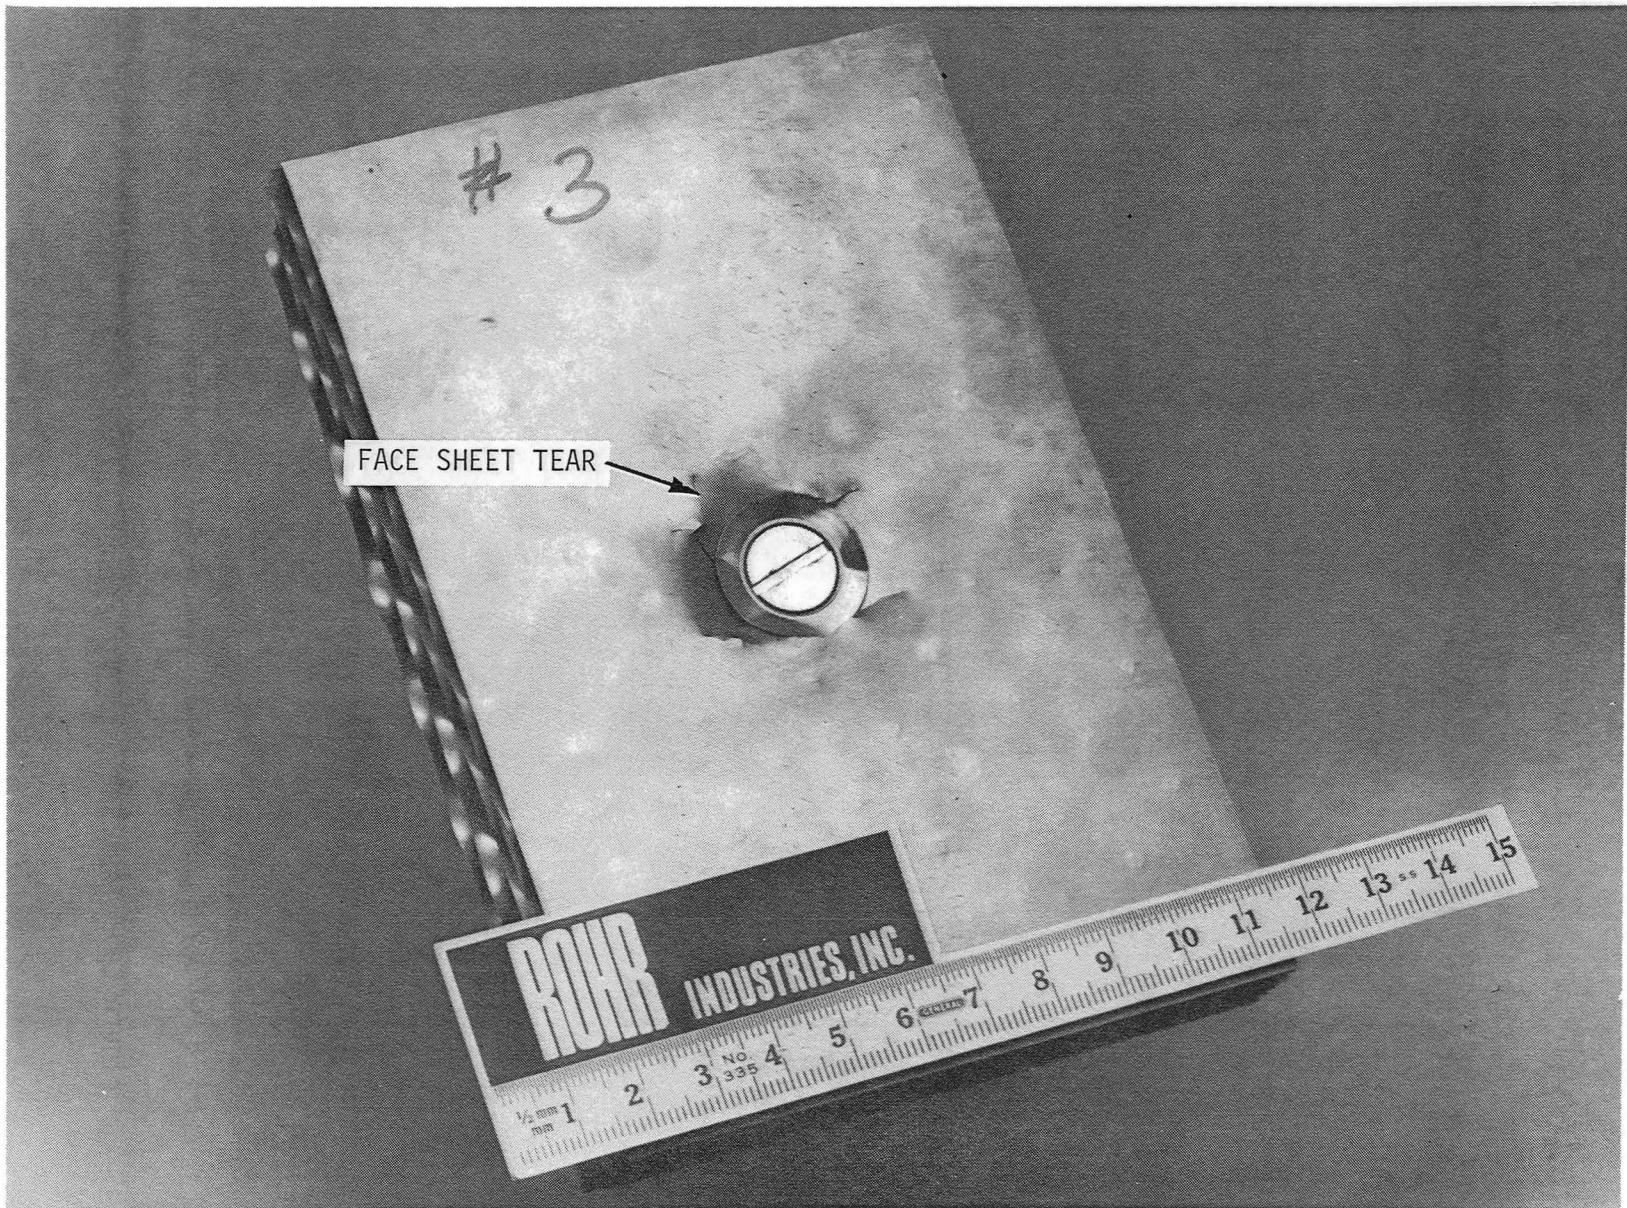
Figure 15. Typical Outer Face Sheet Tearout and Internal Panel Damage Failure Mode

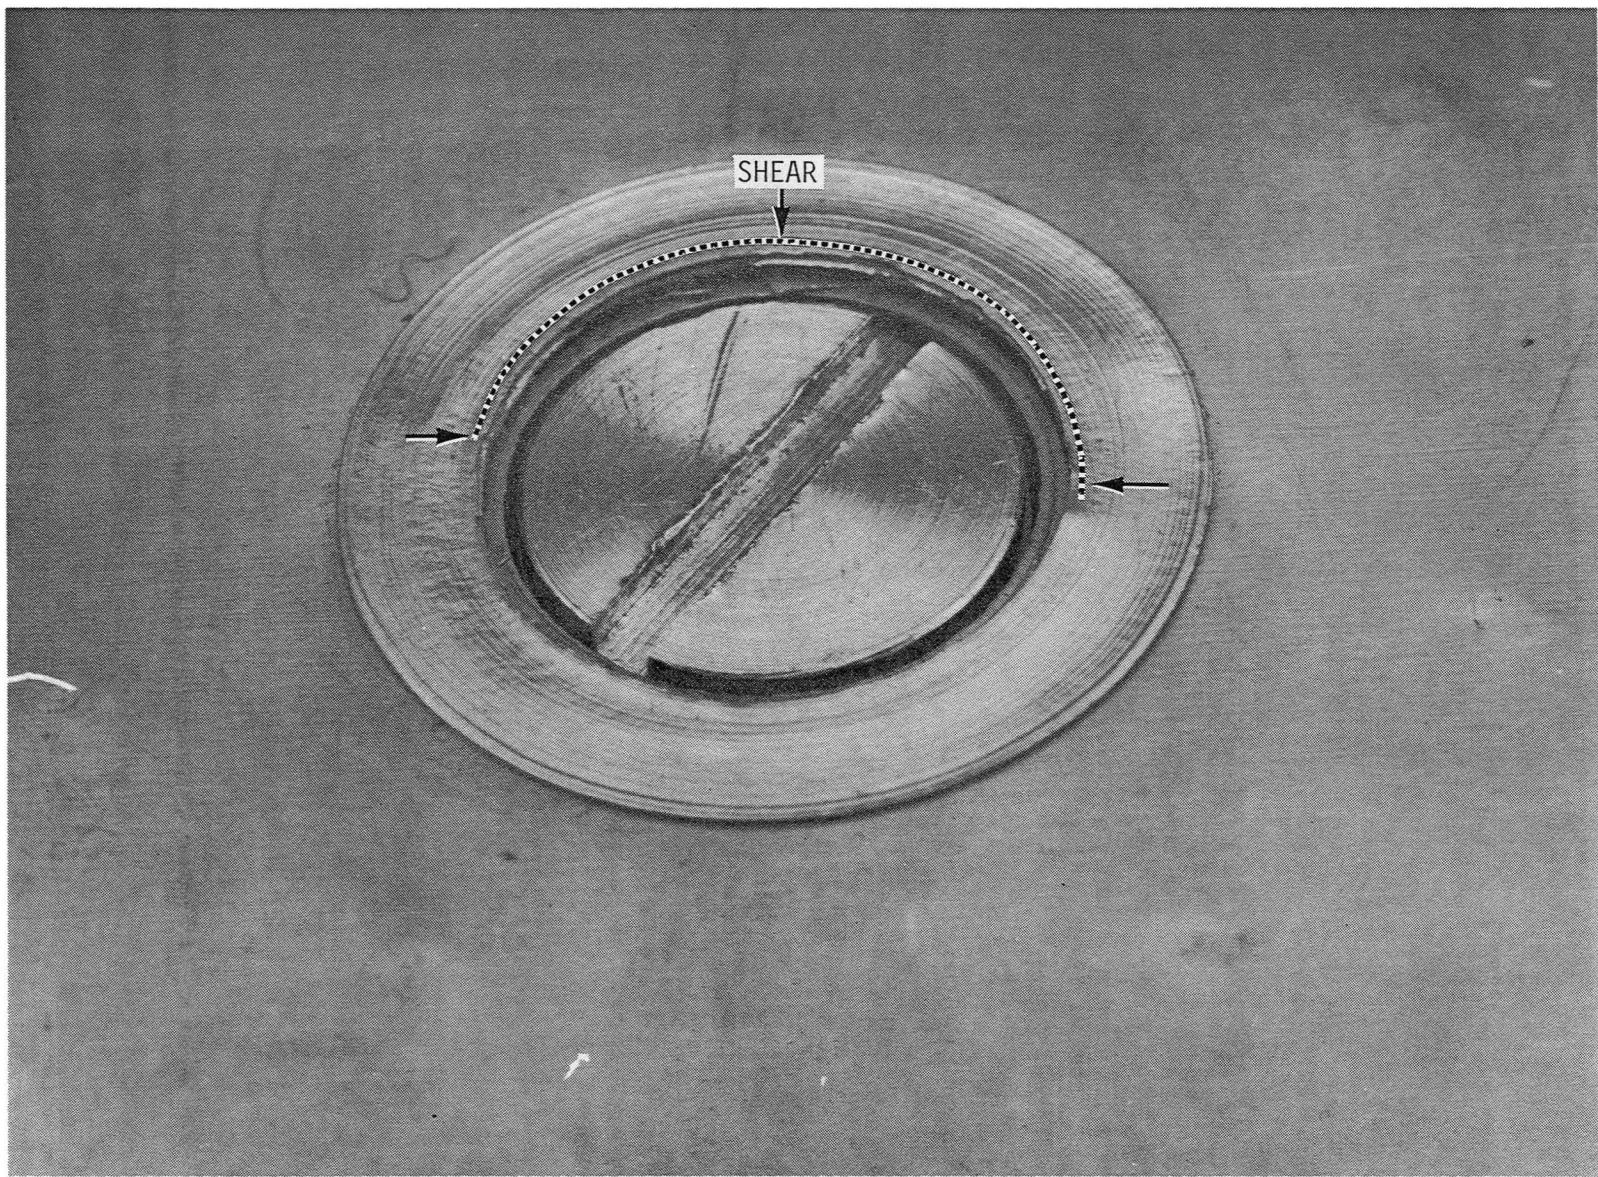
The test results are shown in Table 9. The results of the test show minimum values of 245 N (55 pounds) for limit load and 636 N (143 pounds) for ultimate load. These loads are large when compared to the design requirements which are 107 N (24 pounds) for limit and 160 N (36 pounds) for ultimate loads. There were two failure modes in this test. They were outer face sheet tear-out with internal panel failure, as shown in Figure 15, and shear of fastener insert flange as shown in Figure 16. Photomicrographs of the fastener insert flange show that shear failure

Figure 16. Typical Shear of Fastener Insert Flange Failure Mode

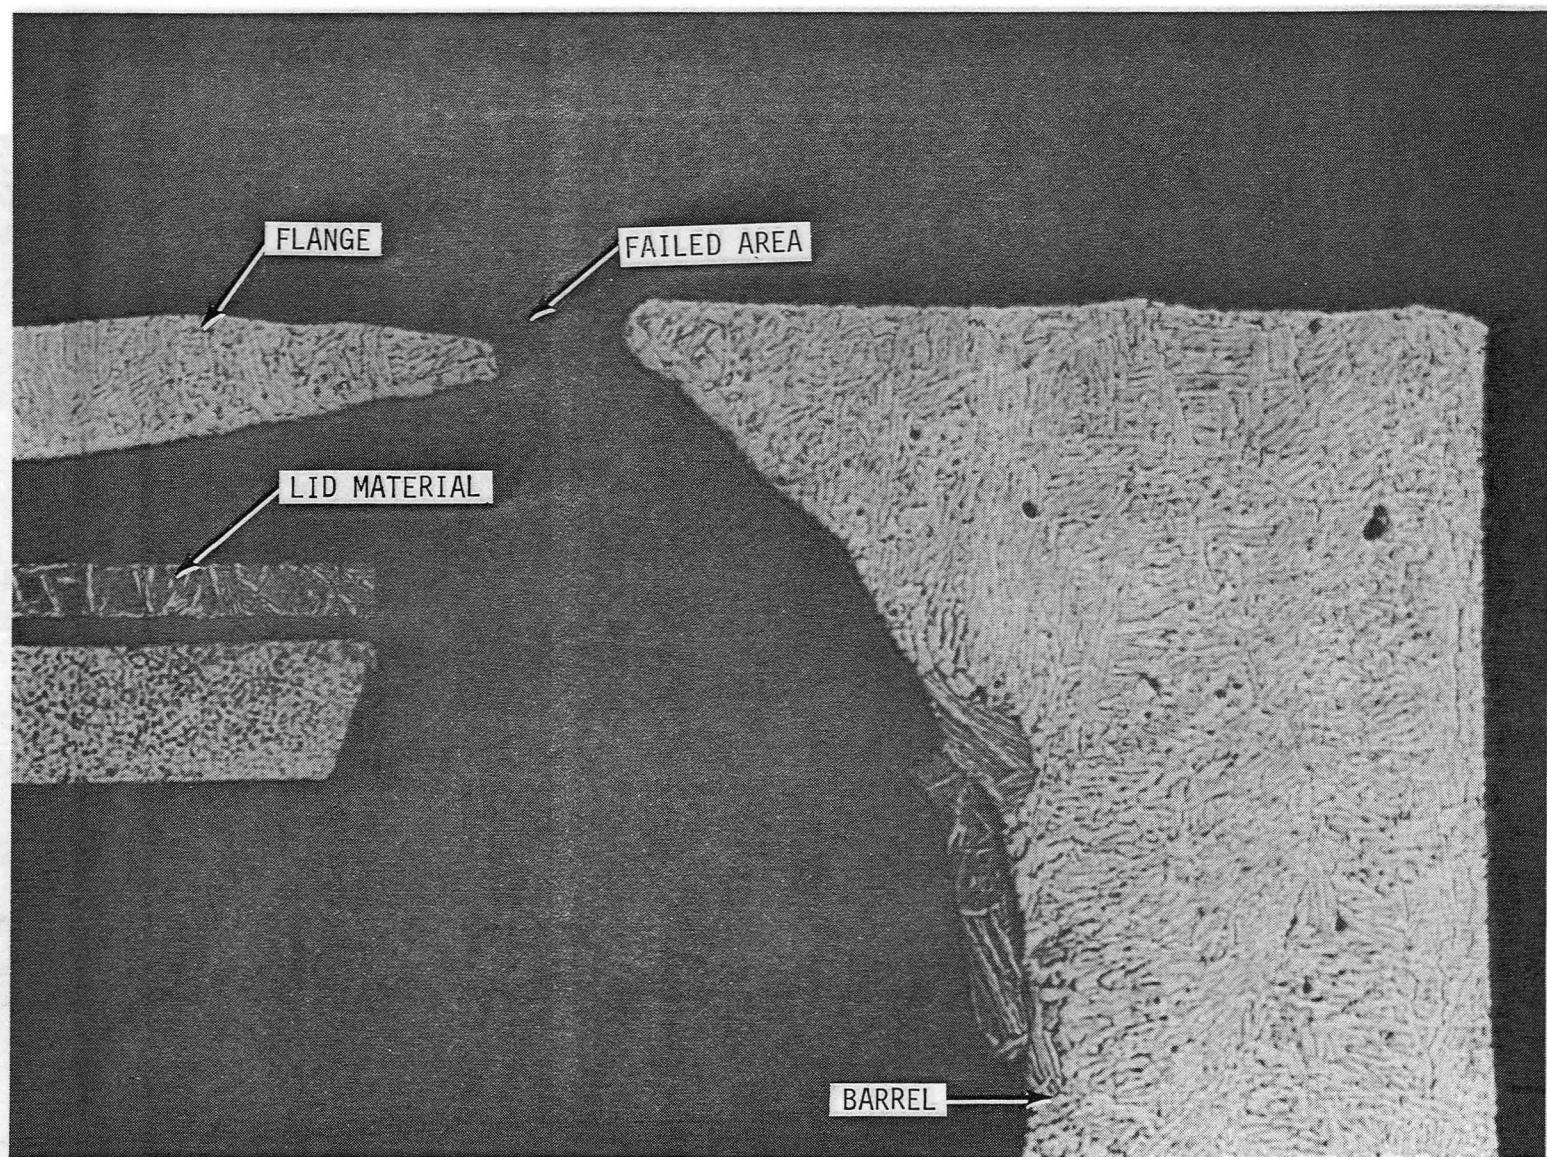
was due to machining the insert flange too thin as shown in Figure 17. This explains the lower ultimate test loads found for these specimens. The actual production parts will require tighter tolerances on the machining of this insert flange.

Figure 17. Photomicrograph Shows Over-machining of Fastener Insert Flange

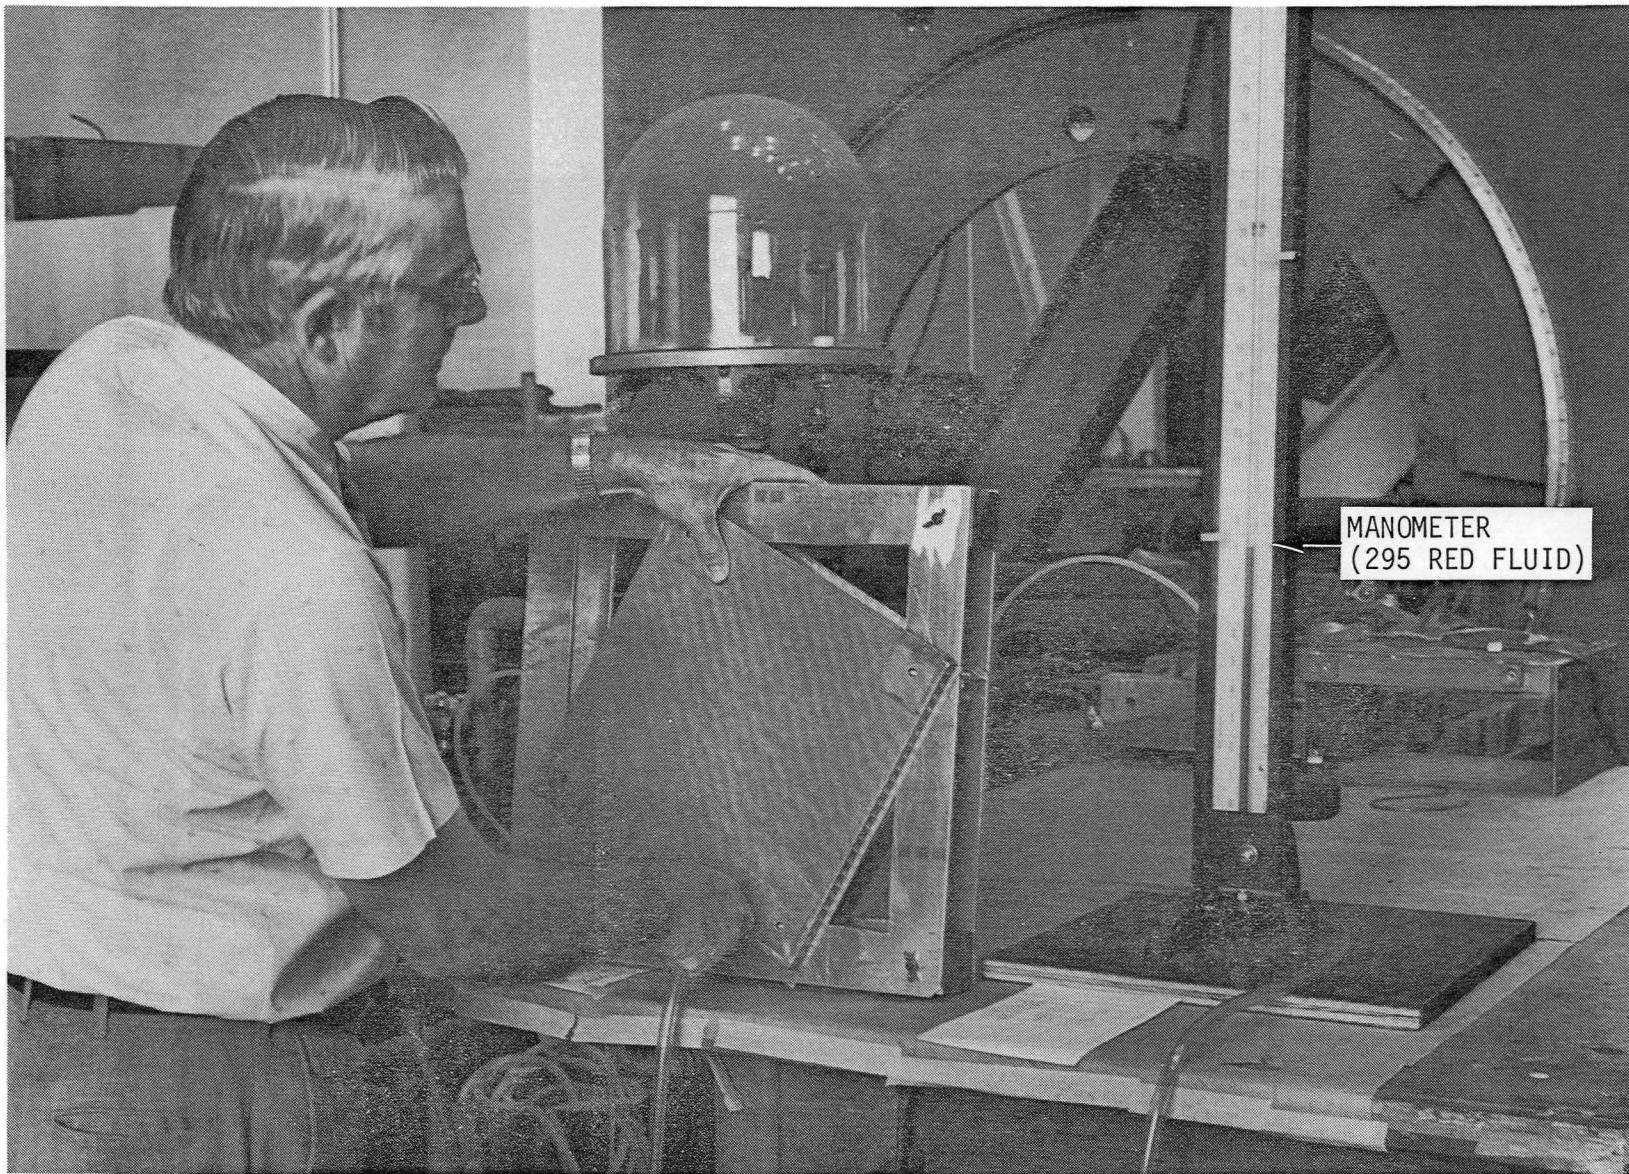
An internal pressure check to 6.895 KPa (1 psi) was performed, using a Meriam Manometer with Meriam 295 Red Fluid (2.95 specific gravity) shown in Figure 34. While the panel was being pressurized, it was observed for noise and bulges. One previously rejected panel with known dimpled sheet to face sheet bond voids was tested to failure as a standard. Where the known voids were, a bulge would occur; when additional joints failed, a loud noise was heard.

Figure 34. Multi-Wall Panel being Pressure Tested to 1 PSI Internal Pressure

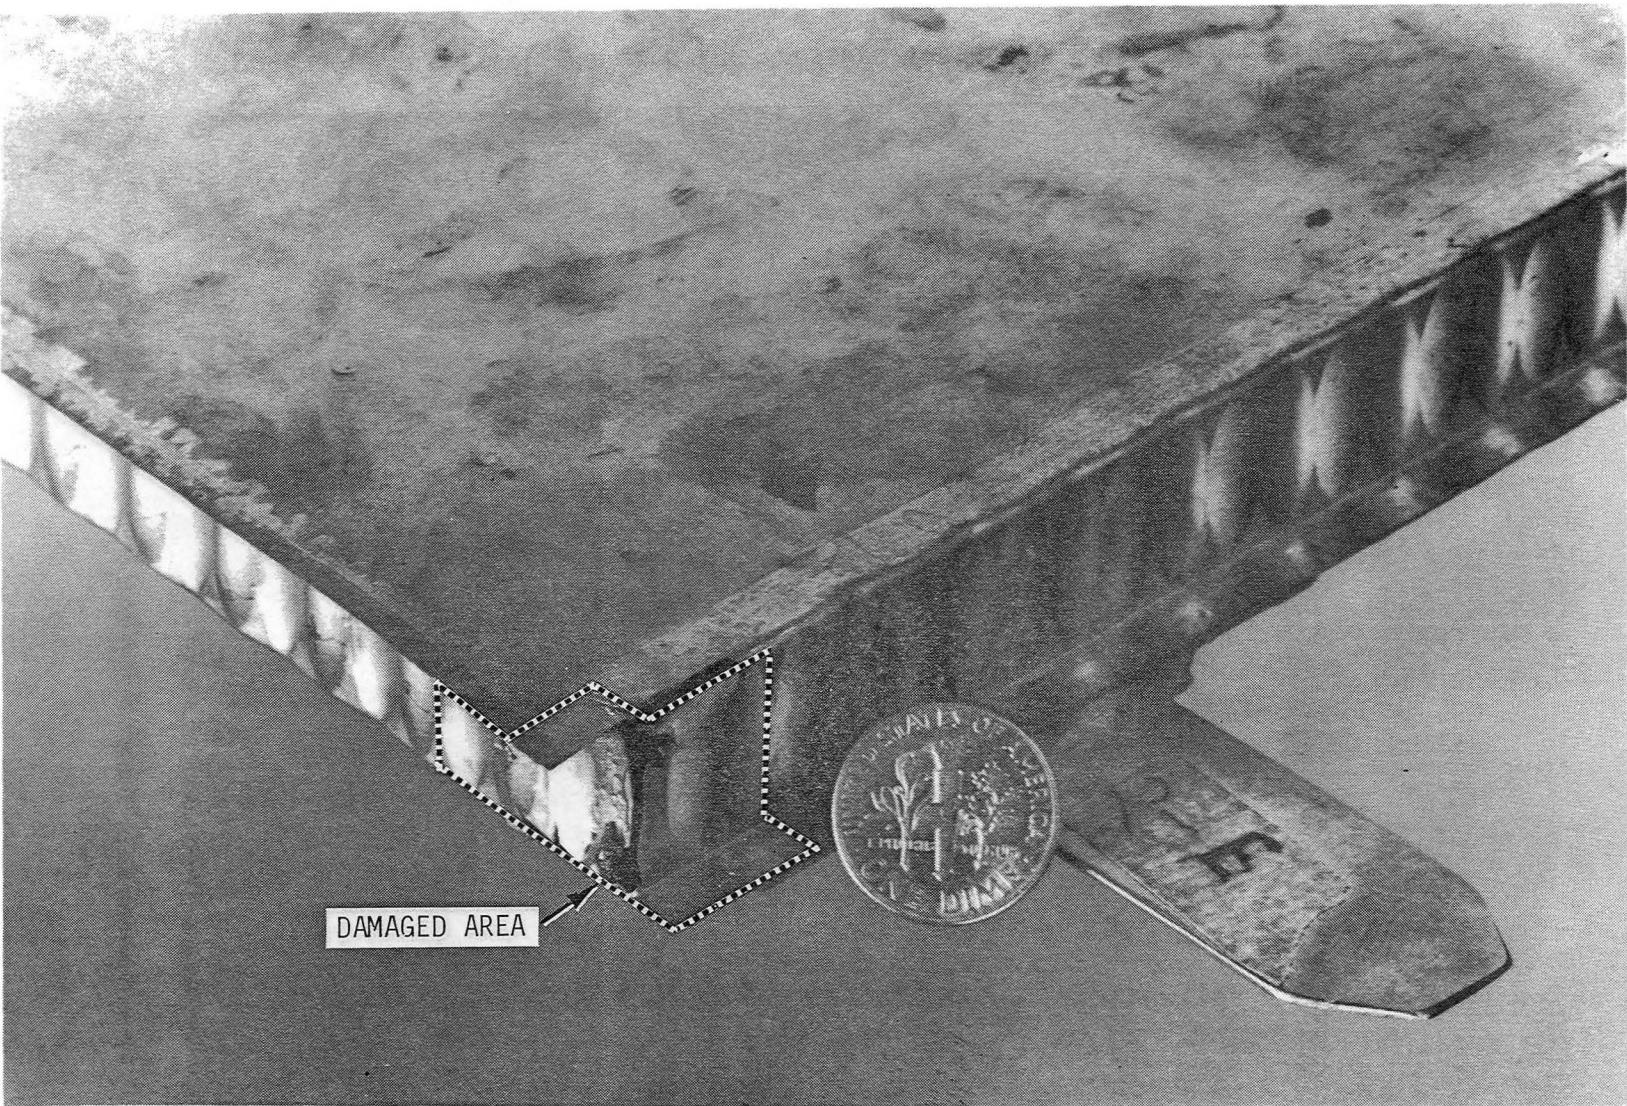
The visual inspection showed that some panels had waviness of the face sheets, some had been damaged from handling, some also had very small openings at the intersection of the side closures at the corner; see Figures 35 through 40. Previous tests showed that waviness of the face sheets was not a structural problem. The damaged areas were repaired by LID bonding a small patch over the affected area. Experience in handling and the possible use of protective aid during the fabrication process is expected to eliminate this type of damage.

Figure 35. Damaged Corner of Panel

Figure 36. Panel was Repaired after Damage

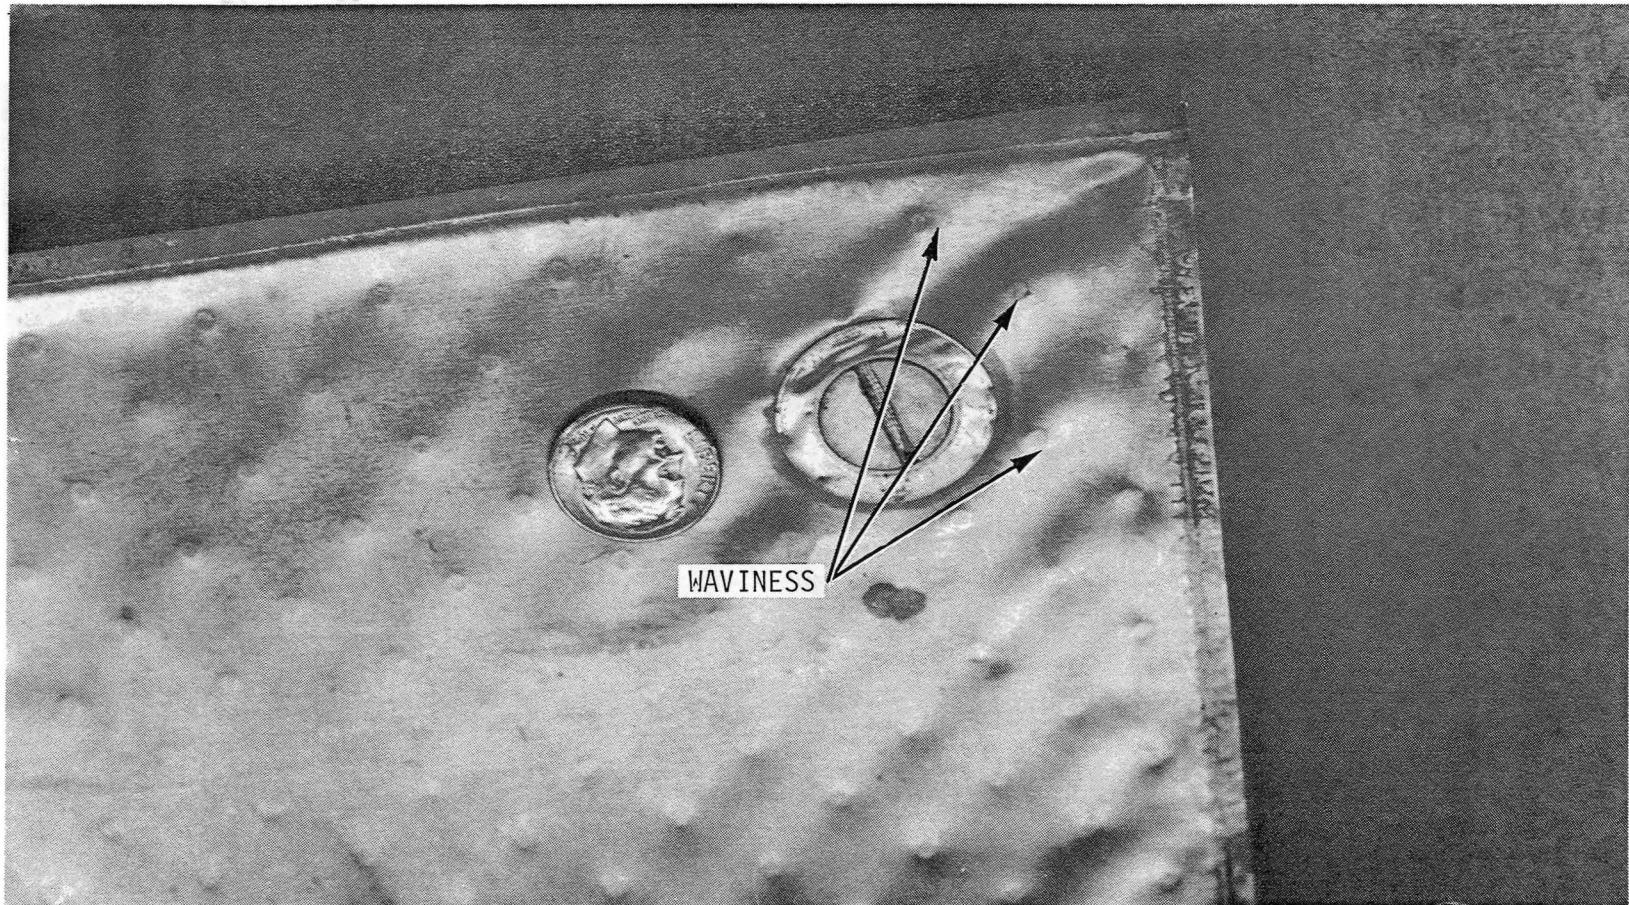
Figure 38. Waviness of Top Skin to 0.33mm (0.013 inch) Deep

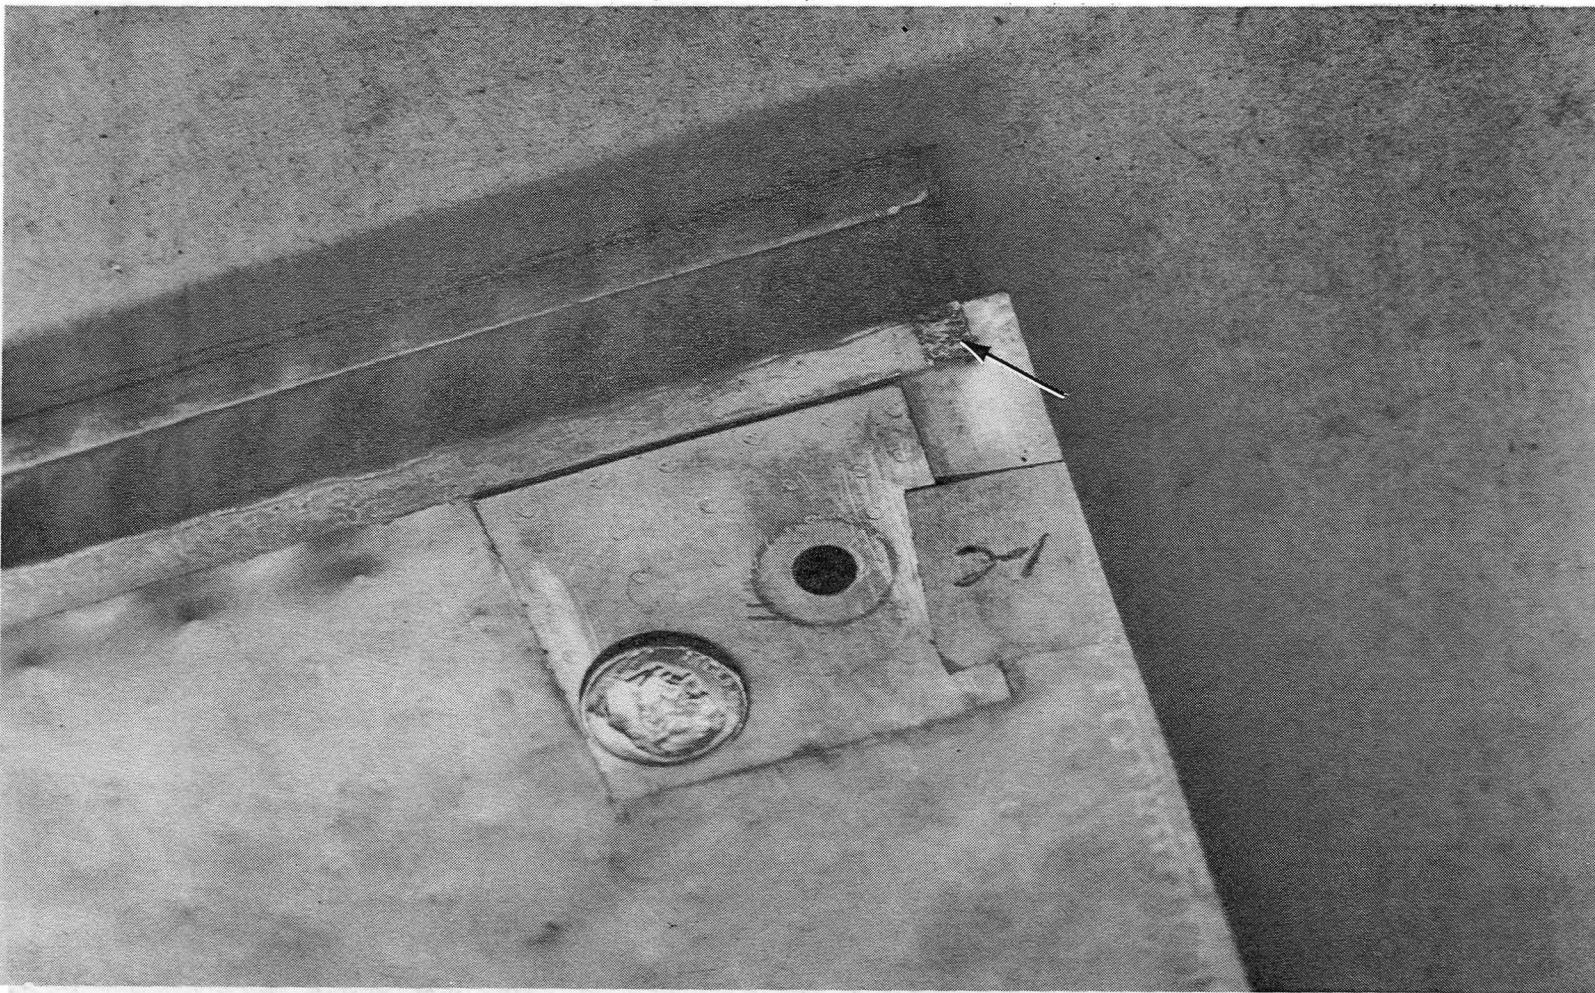
Figure 39. A Small Opening at the Intersection of Edge Closures and Skin was Closed with a 0.08mm (0.003 inch) by 5mm (0.2 inch) by 8mm (0.3 inch) Patch Resistance Welded Over the Opening
